8.0 ORBITER POST LANDING DEBRIS ASSESSMENT

After the 2:20 a.m. local/eastern time landing on 29 May 2000, a post landing inspection of OV-104 Atlantis was conducted at the Kennedy Space Center on SLF runway 15 and in Orbiter Processing Facility bay 3. This inspection was performed to identify debris impact damage and, if possible, debris sources.

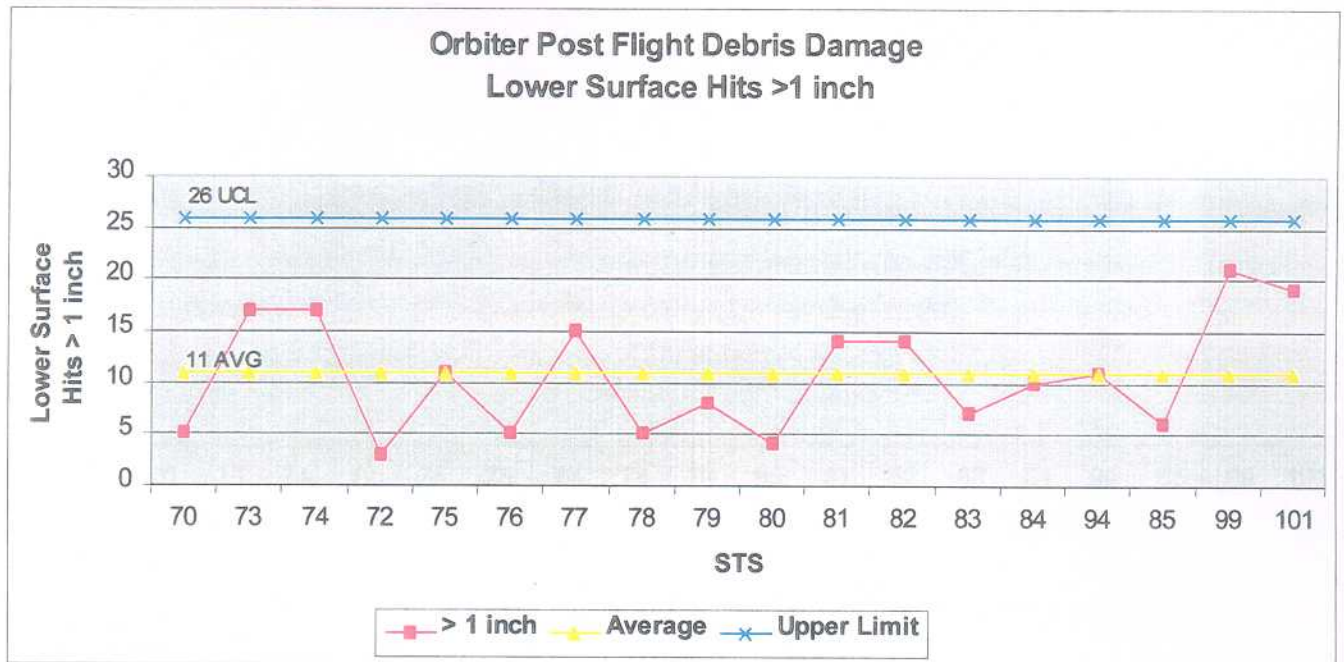
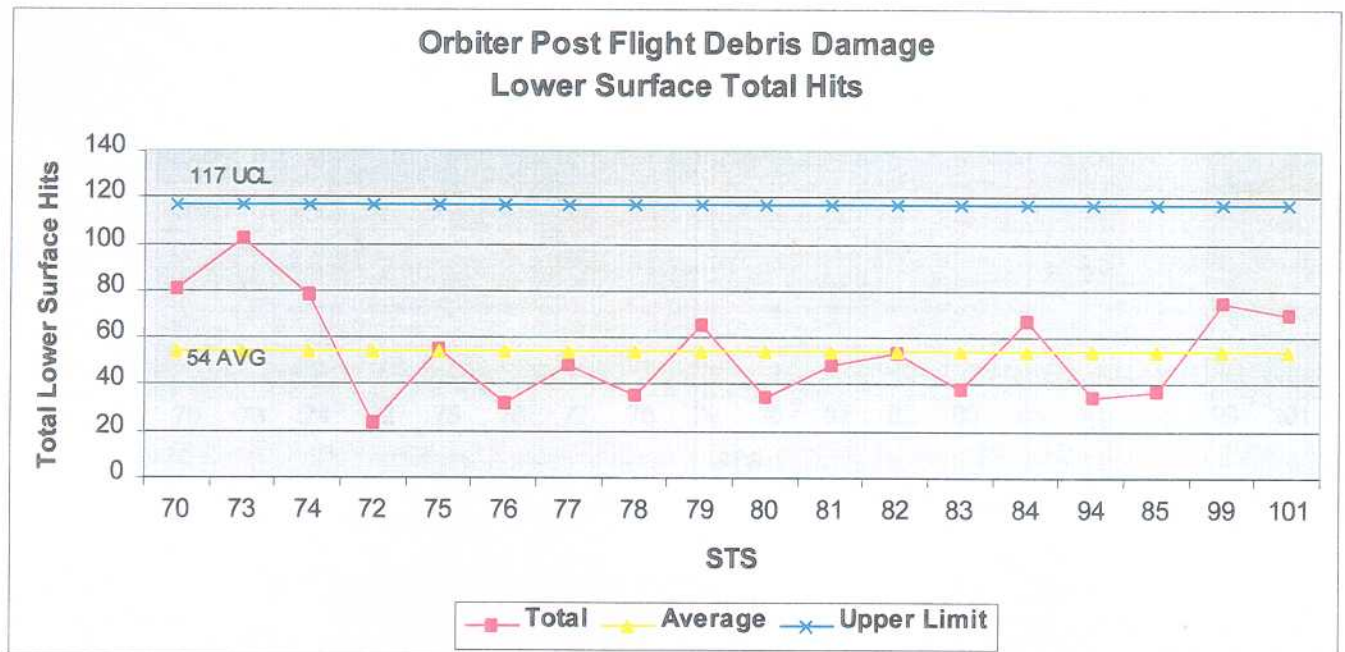
Figure 5: Orbiter Post Flight Debris Damage Summary

In summary, the total number of Orbiter TPS debris hits, and the number of hits 1-inch or larger, were “in family”.

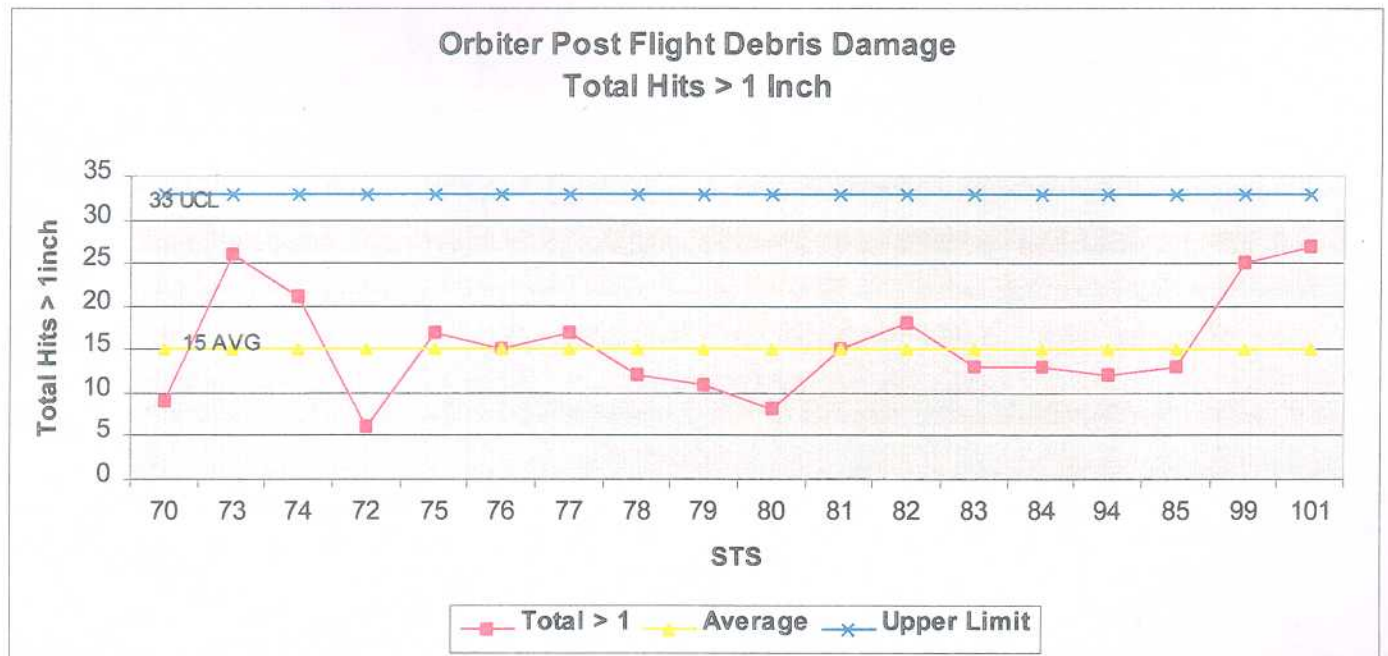
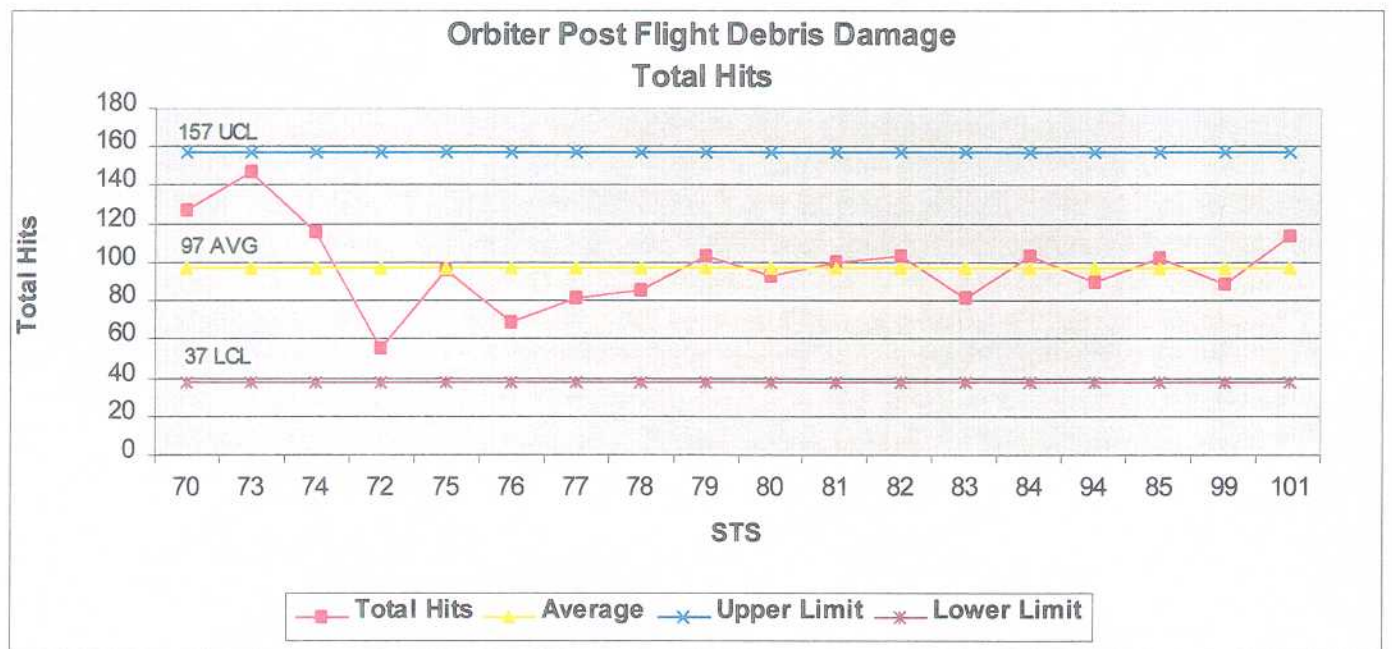
Figure 6: Control Limits for Lower Surface Hits

The Orbiter lower surface sustained 70 total hits, of which 19 had a major dimension of 1-inch or larger. Some of these damage sites (23 hits with 5 larger than 1-inch) were located in the area from the nose gear to the main landing gear wheel wells on both left and right chines, which is consistent with the loss of foam from the ET thrust panels. But the overall quantity and average size of the damage sites compared to previous flights were consequently reduced as a result of the pre-launch TPS venting modification. And some of the hits in this area may also be attributed to impacts from LO2 feedline bellows ice particles.
